2183 USPS Processing & Distribution Ctr REPORT
Multnomah
Final Closure Report April 12, 2012

Final Closure Report

**USPS Portland P&DC
715 Northwest Hoyt Street
Portland, OR 97208**

April 2012

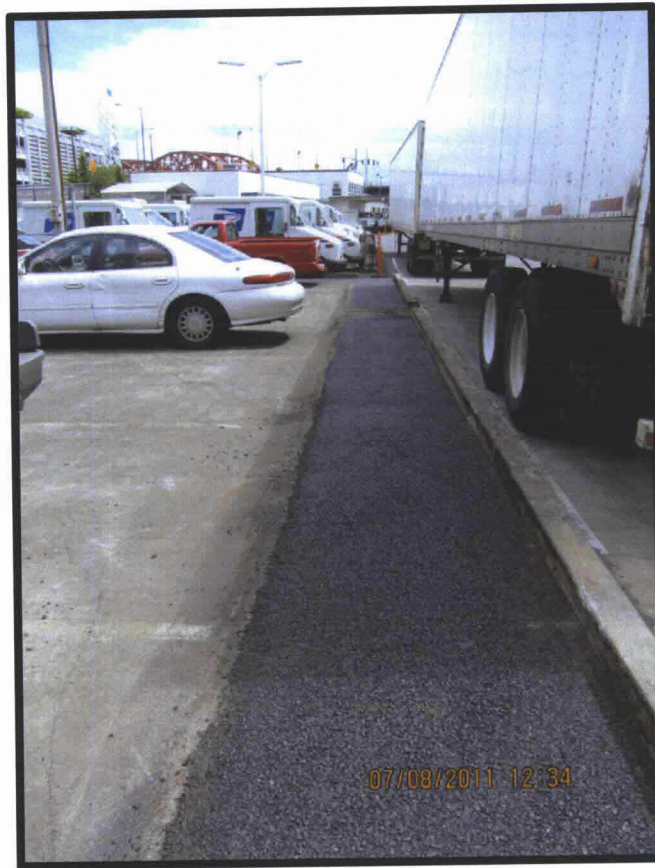
Photo 27 - Looking easterly at pavement repair (former planter) north of abandoned driveway in northwest corner of site (VMF parking lot).

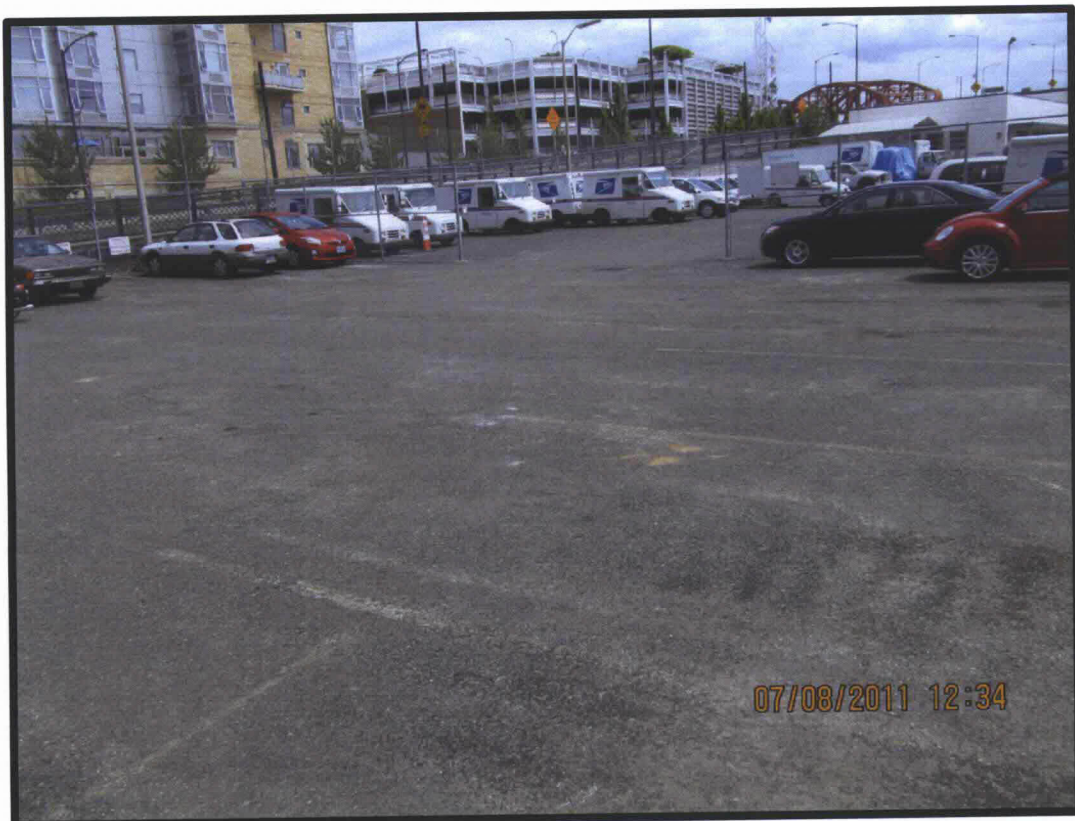
Photo 28 - Looking northeasterly at VMF parking lot, northwest corner of Site.

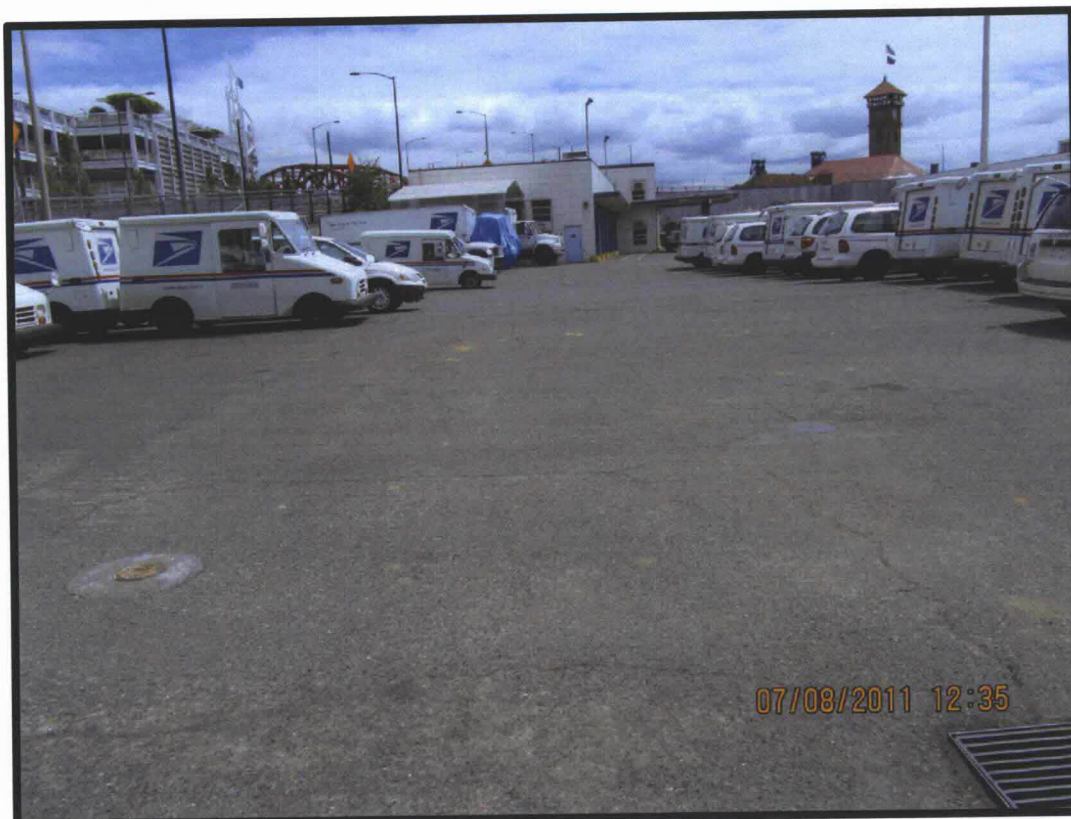
Photo 29 - Looking easterly at VMF parking lot.

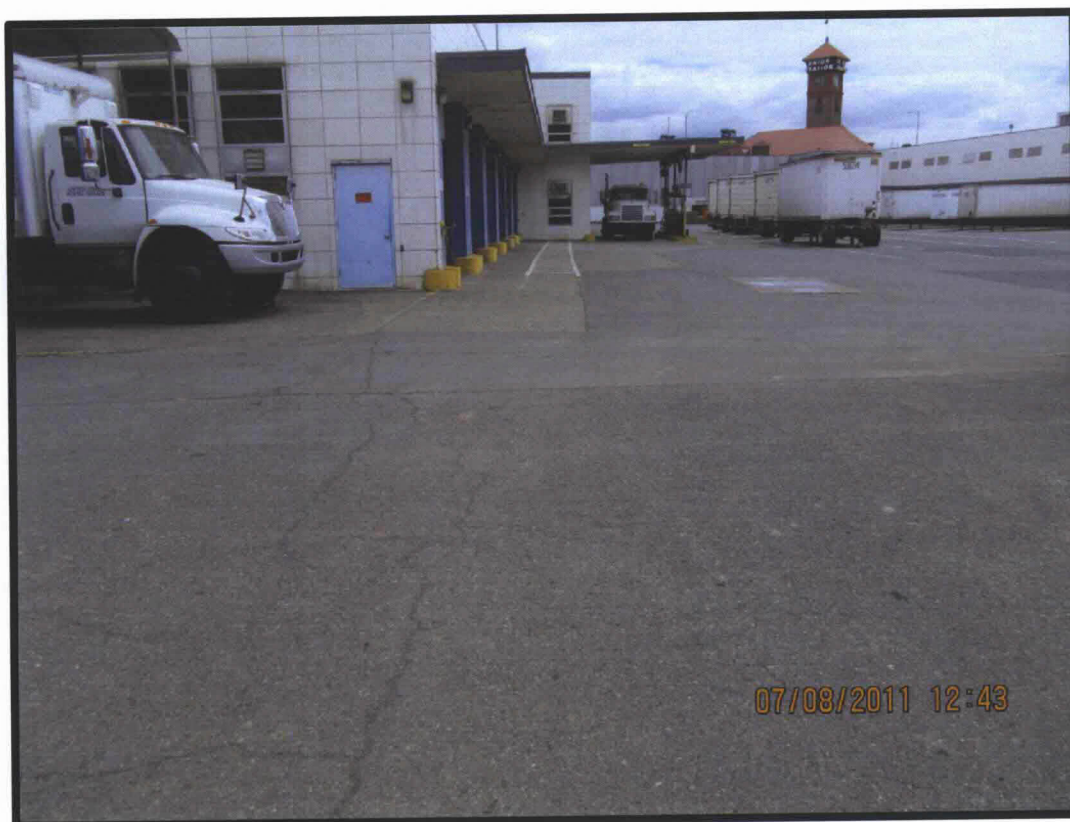
Photo 30 - Looking easterly at drive lane south of VMF.

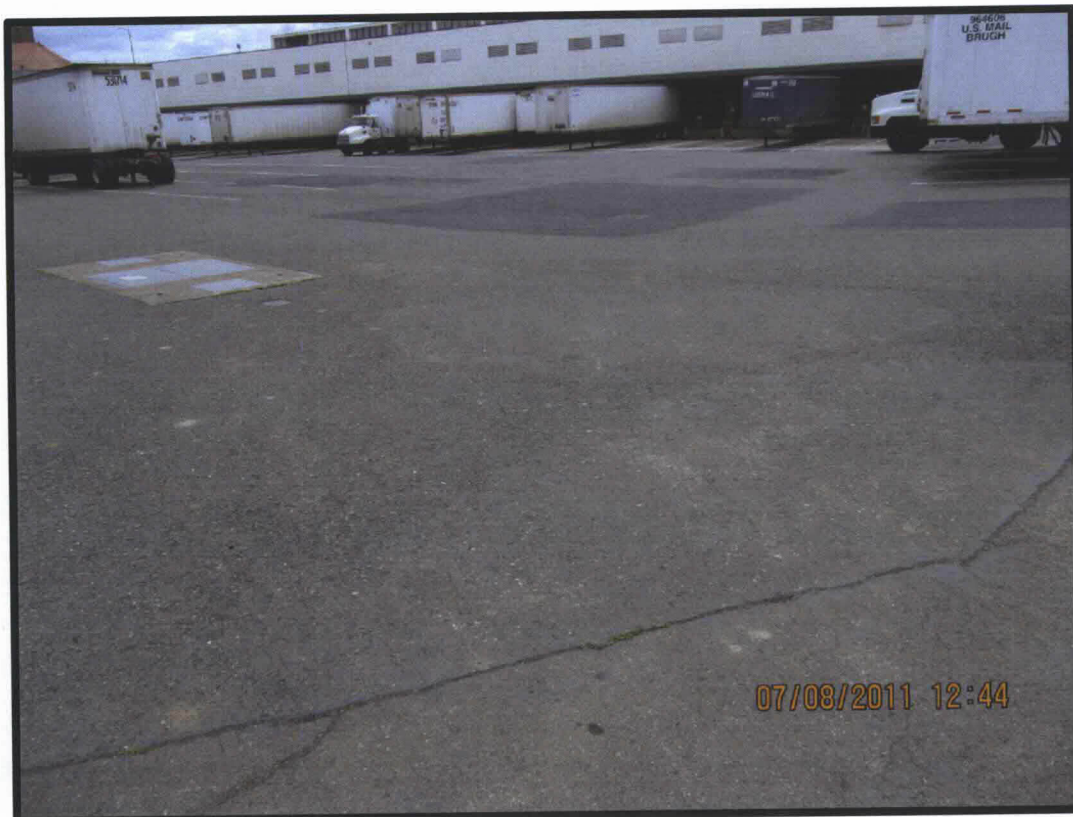
Photo 31 - Looking southeasterly at north truck dock.

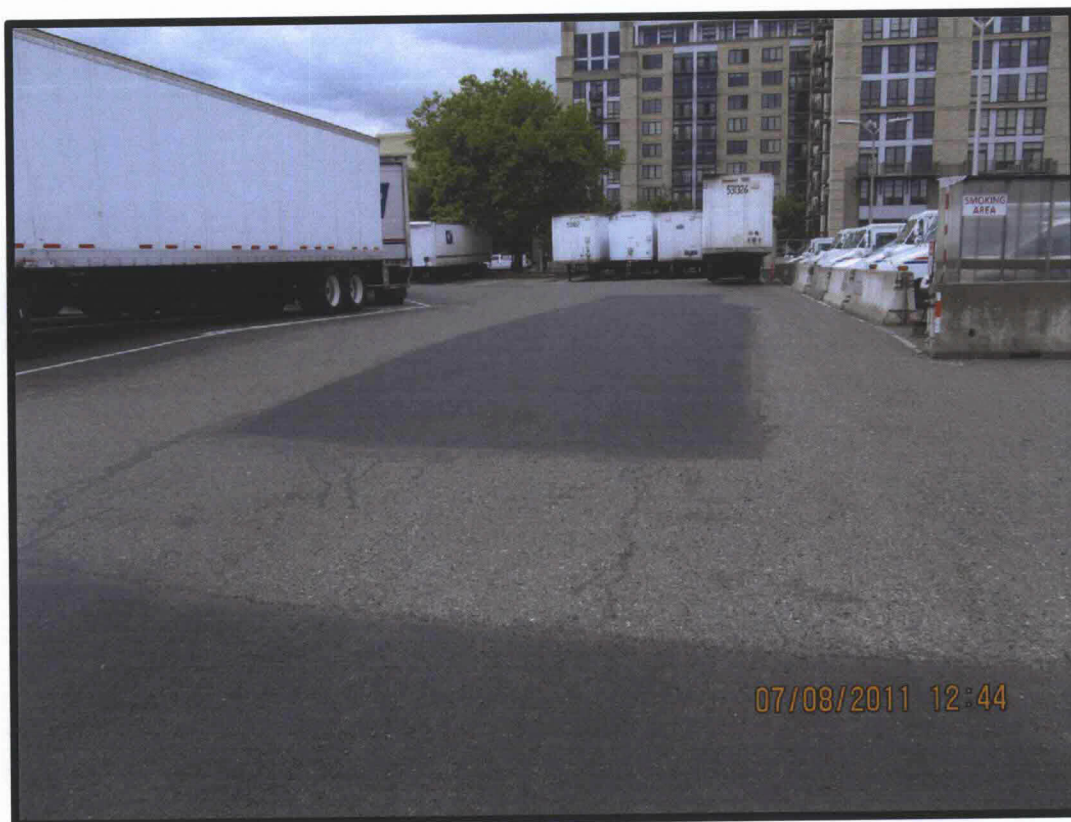
Photo 32 - Looking westerly at pavement repair and north drive lane for truck parking lot.

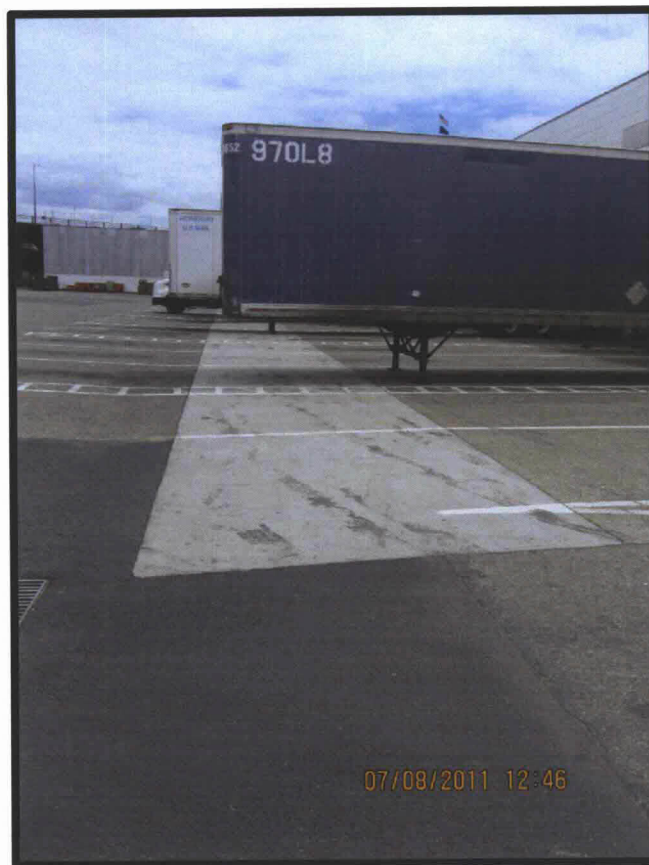
Photo 35 - Looking easterly at pavement repair and north truck dock area.

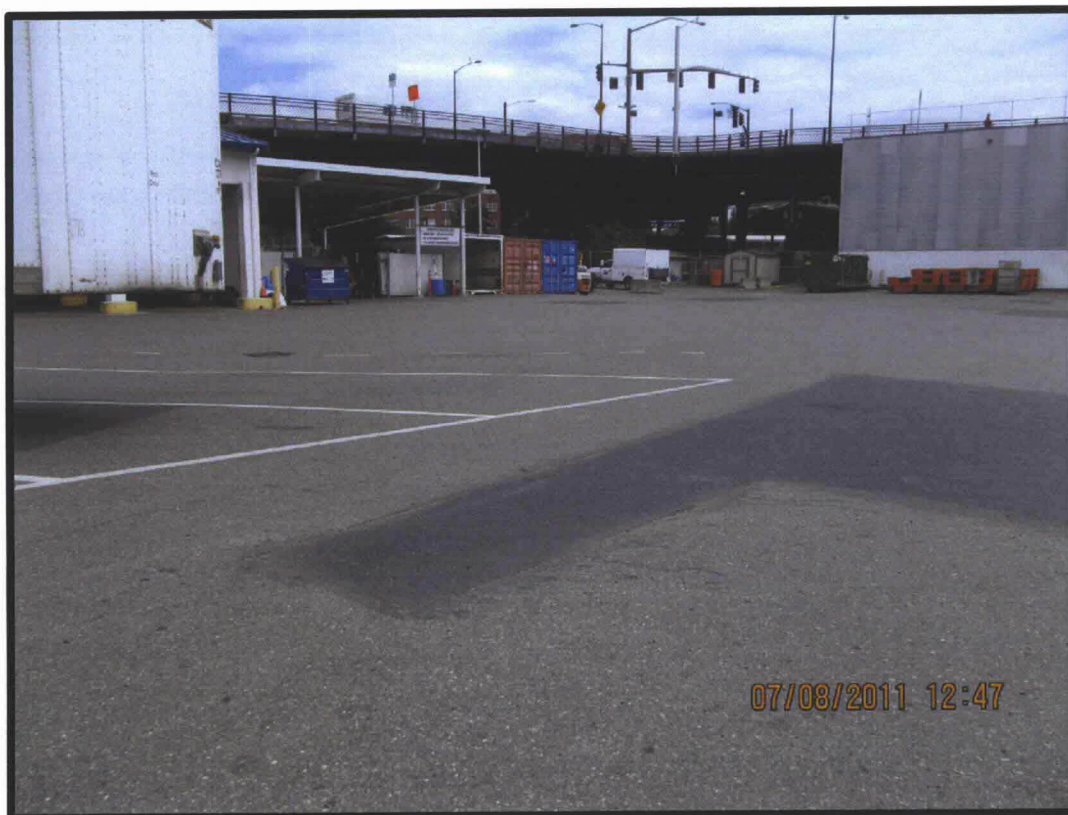
Photo 36 - Looking northeasterly at pavement repair and northeast corner of Site.

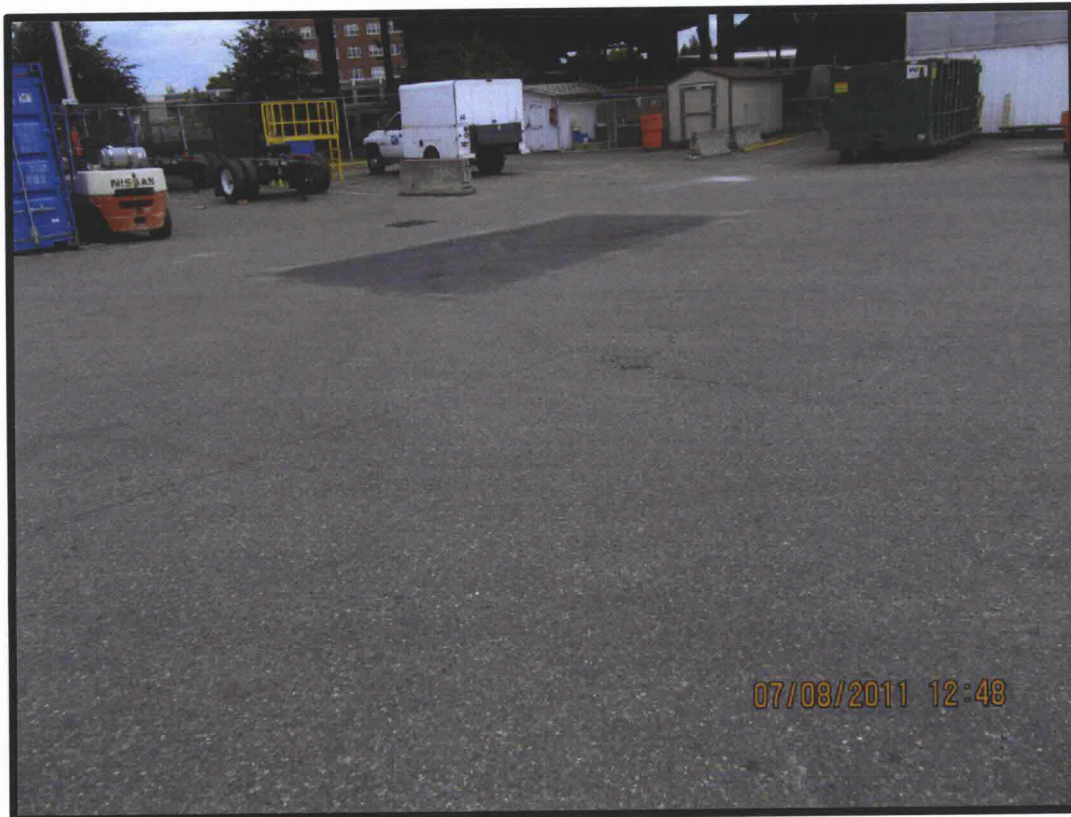
Photo 38 - Looking northeasterly at pavement repair and northeast corner of Site.
